Hall Function Space

Reinstatement of Period Features

Building Exterior

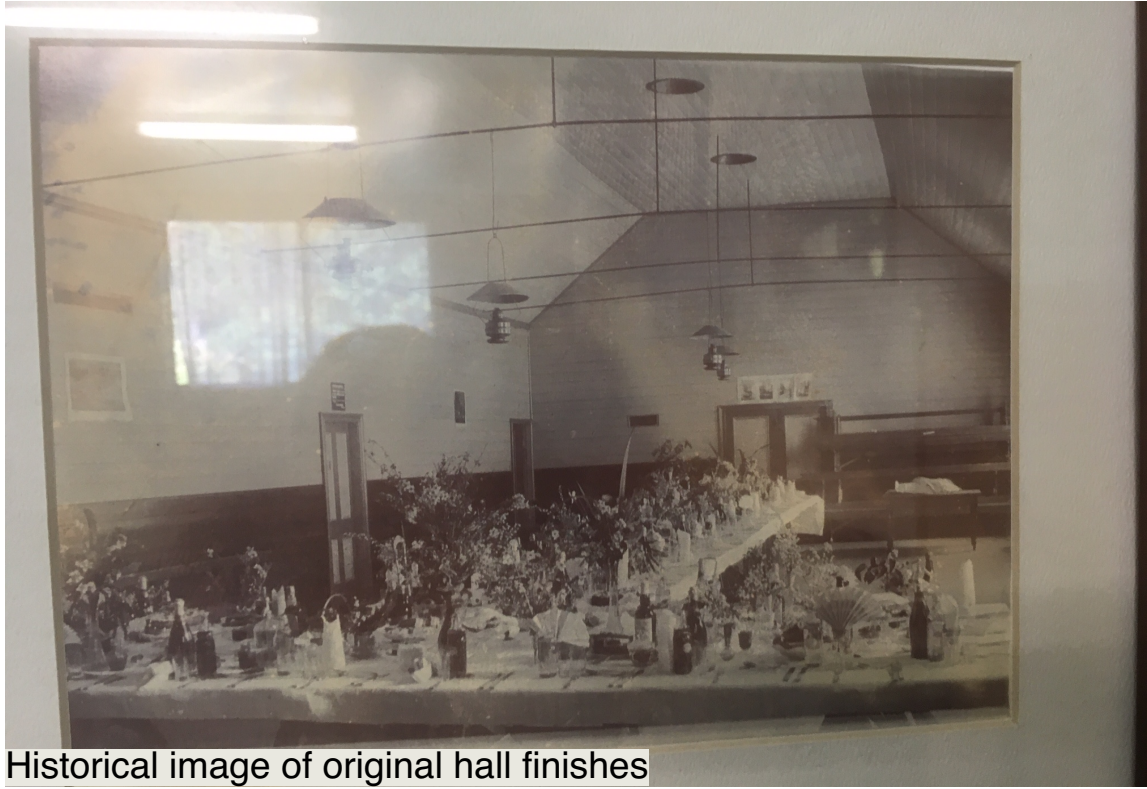
Retain and make good the existing wall timber lining boards. Damaged boards to be replaced.

Retain and make good the existing ceiling timber lining boards.

Historical image of original hall finishes

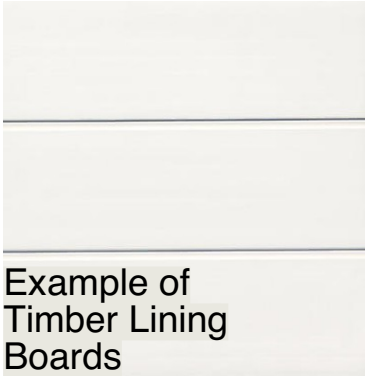
Example of Timber Lining Boards

Reinstate the Western brick wall to look like the Eastern wall with timber lining boards. Existing brick wall to be lined with white timber lining boards.

Existing brick wall to be lined with white timber lining boards.

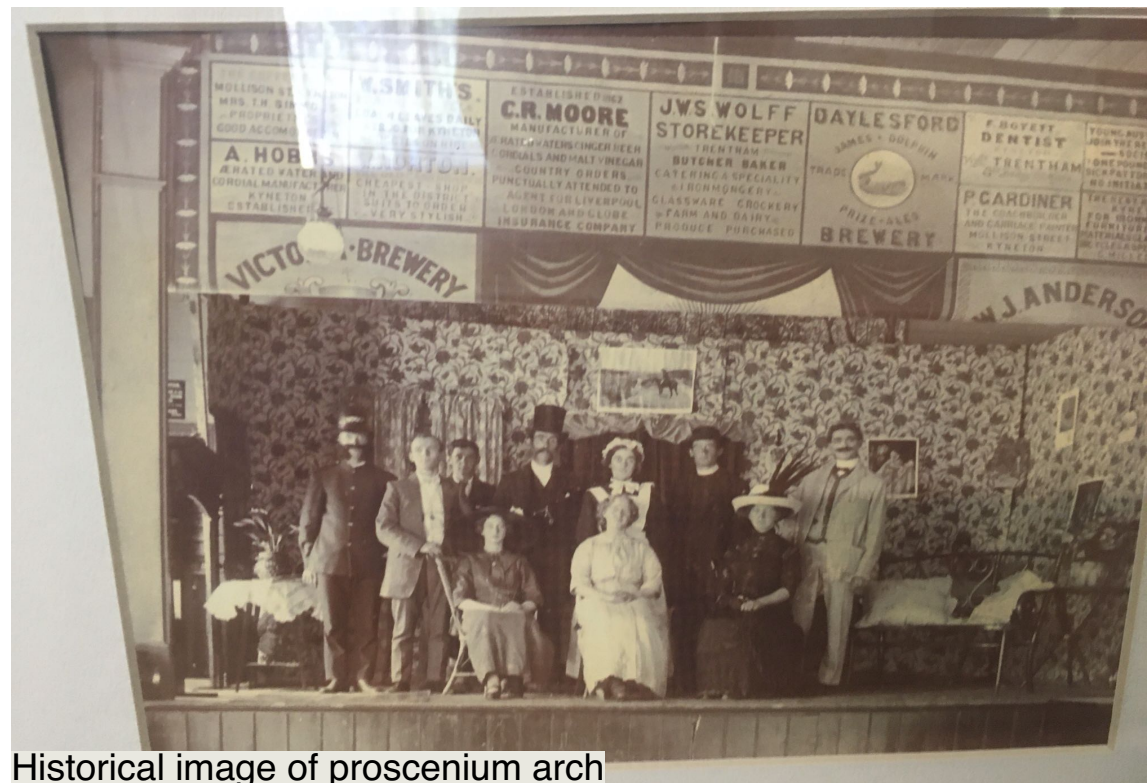
Historical image of proscenium arch

Salvage Proscenium Arch to be Reused or Preserved

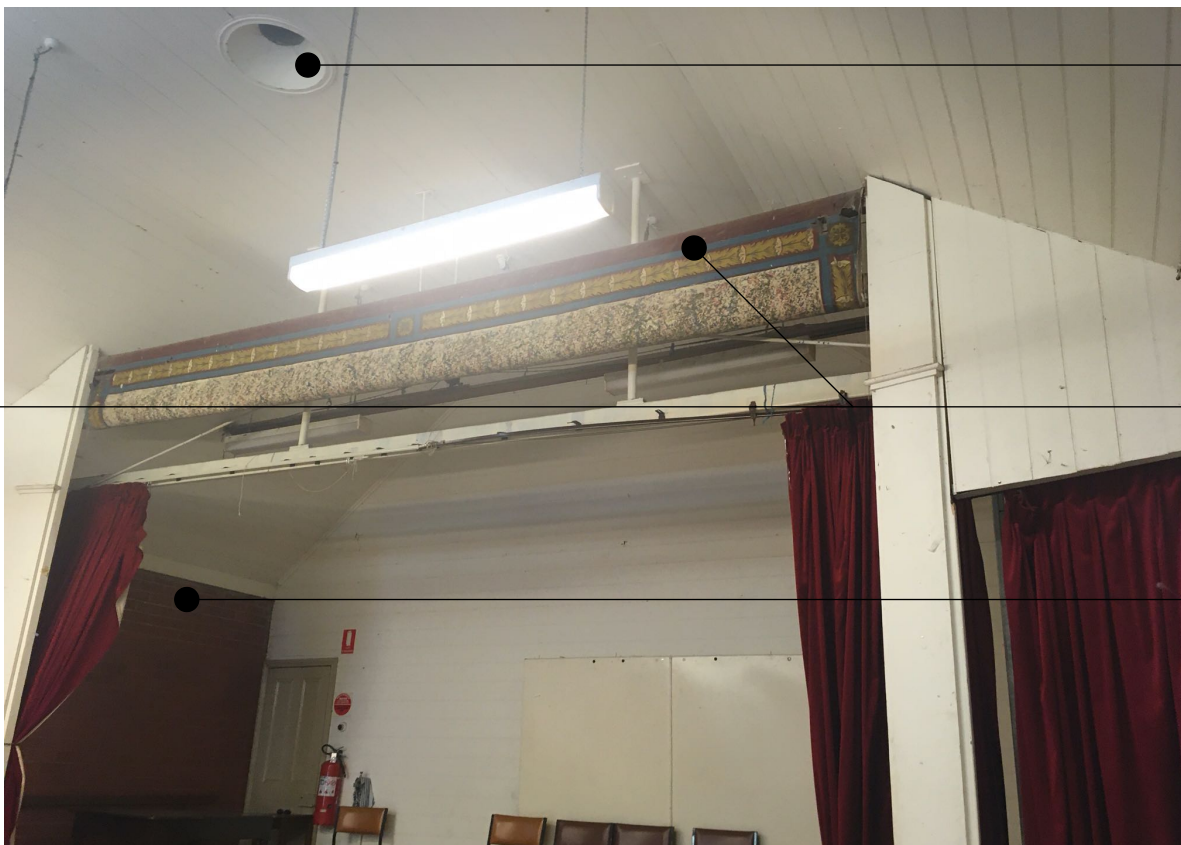
Ventilation grills to be retained and reused for AC.

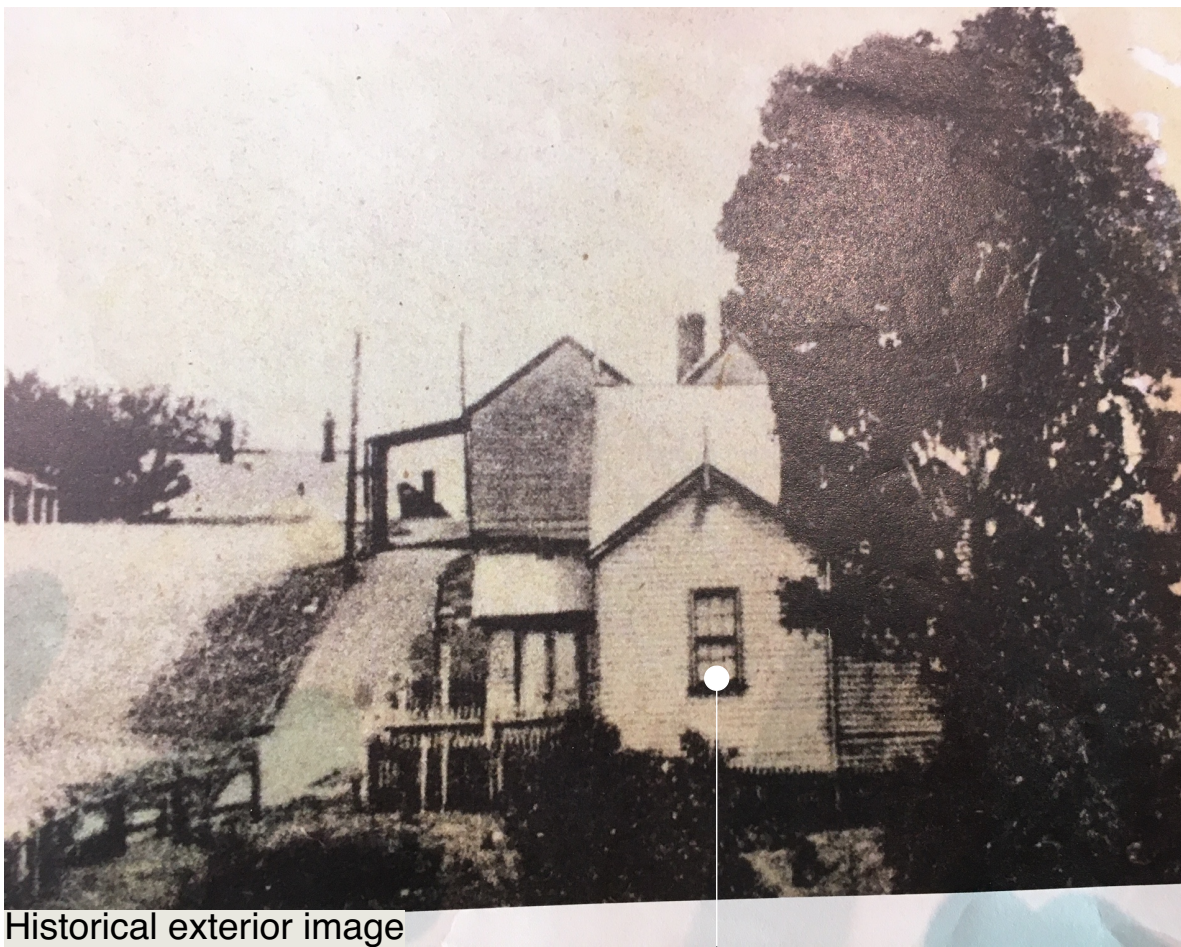
Historical exterior image

Original 12-pane glass window to be reinstated.

Reinstate original galvanised zinc roof.
