# Preliminary Soil Contamination Assessment

Glenlyon Reserve, Suttons Lane, Glenlyon

Hepburn Shire Council

22/11/2019

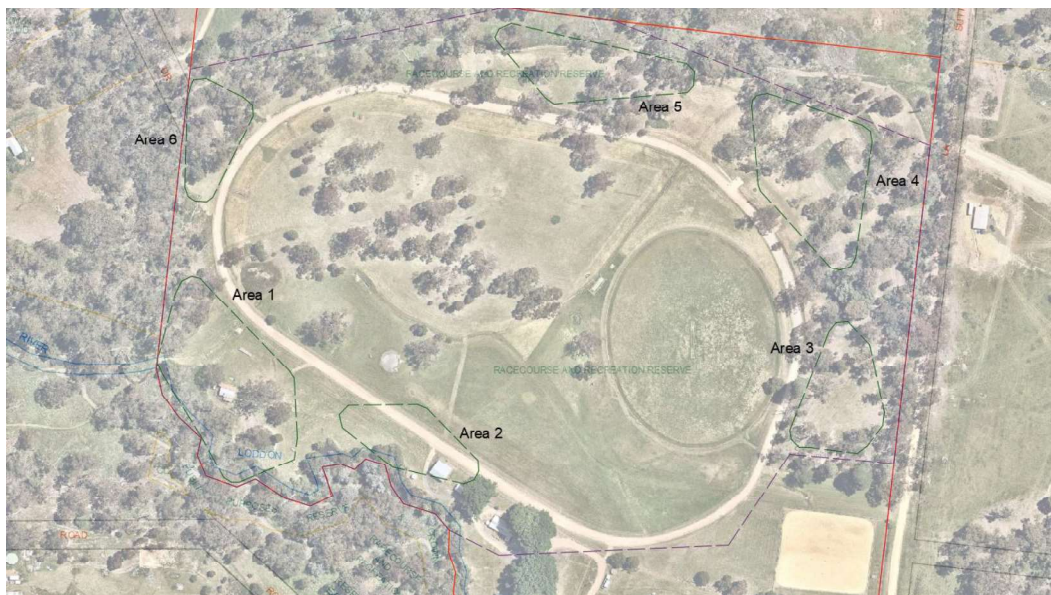
Figure 4-1: Shooting and clay target launching areas

- Shooting activities are restricted to clay targets only
- Clay targets are launched from six different areas (shown on Figure 4-1 below)

- All targets and shooting is directed into the centre of the Glenlyon Reserve
- Mobile traps are distributed throughout the central portion of the site to capture target fragments
- The west portion of the site occupied by the cricket oval and dressage field are listed as a zero-debris area

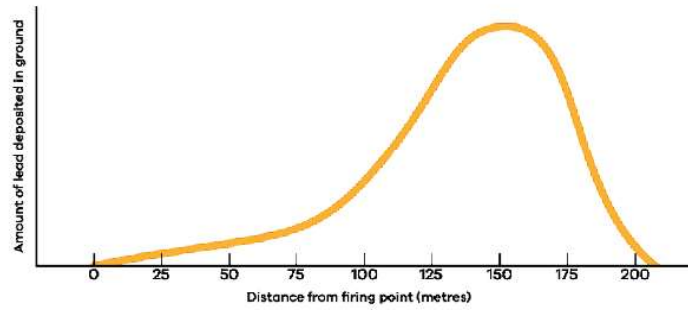
Figure 4-2: Lead contamination at a skeet or trap range based on distance from the firing point<sup>2</sup>

Based on the information around the shooting activities carried out at the site (shotgun clay target shooting operated across six areas around the perimeter of the site) and typical ranges of impacts based on these activities, an estimated area of impact has been identified (see Figure 4-2 and Figure 4-3 below).

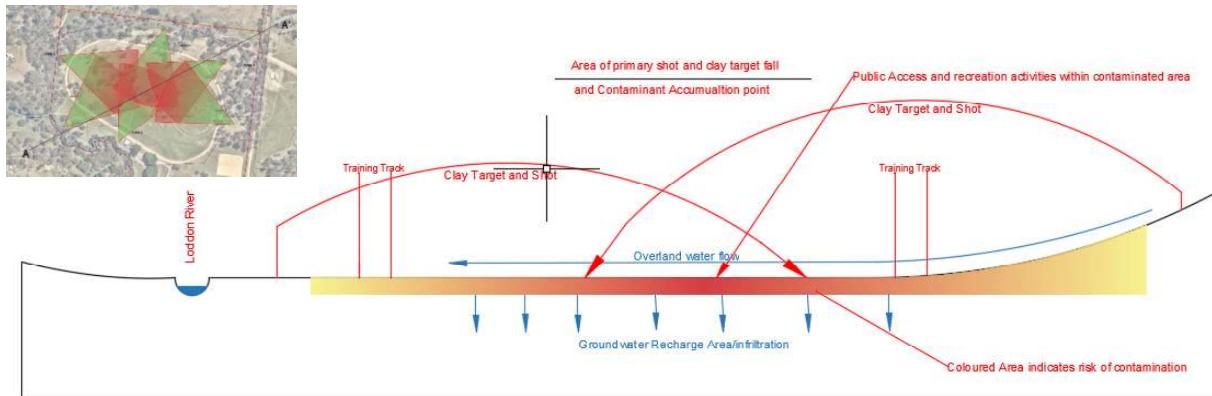
Figure 4-4: Preliminary Contaminant Pathways

Based on the site activities the primary pathways Beveridge Williams considers that there is potential for both direct and indirect exposure pathways present at the site. As such additional control measures are likely to be required at the site to provide protection to site users and nearby receptors (Refer to Section 4.4).

In line with EPA Publication 1710 "Guide for managing contamination at shooting ranges" the following management measures would be recommended in order to address the exposure risks from contamination resulting from the shooting activities at the site:
